U.S. ENVIRONMENTAL PROTECTION AGENCY POLLUTION/SITUATION REPORT 2015 Gold King Mine Release SITREP

Subject: Situation Report #9

Gold King Mine Release San Juan County, CO

Date: 08/17/2015

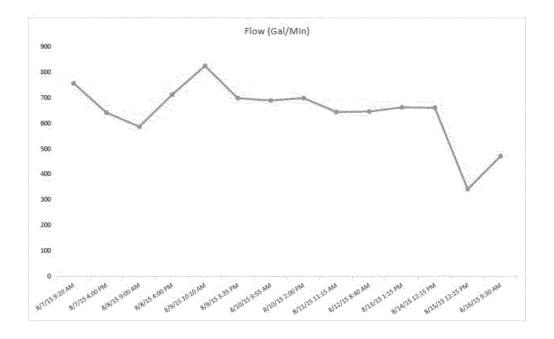
Flow from the mine through the morning of 8/16/2015 is shown in the following chart.

Treated water from the last treatment pond is discharging into Cement Creek. Flow data out of the mine is being collected manually two times per day. Water quality data is being collected at the influent and effluent of the treatment system as well.
